Home Inspection Report

4333 Camellia Court, Pleasanton

Anthony Perjanik
May 11, 2021

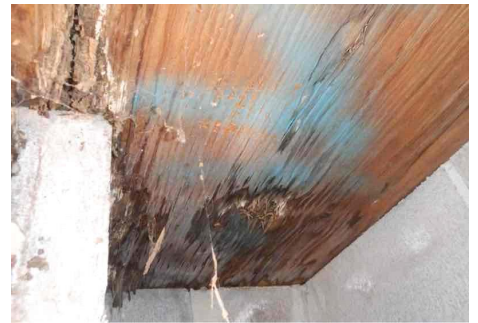
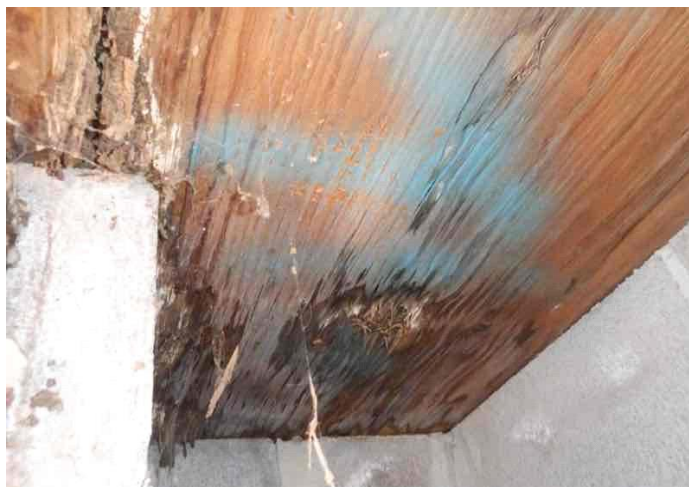
Photo 02

1. The wall framing of the abutment at the front porch shows evidence of water damage. We recommend the advice and services of a licensed structural pest control operator. (See Photo 2)

- ! 1. The wall framing of the abutment at the front porch shows evidence of water damage. We recommend the advice and services of a licensed structural pest control operator. (See Photo 2)

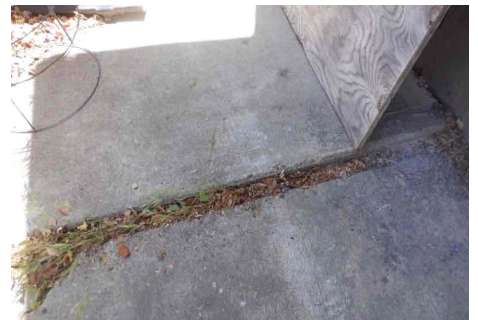
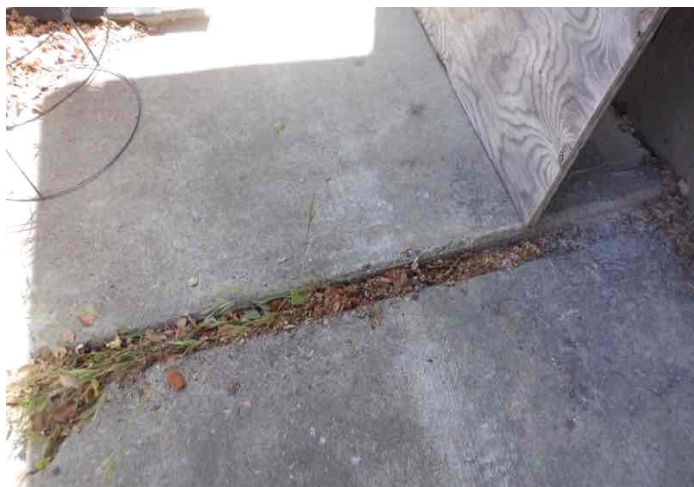
Photo 01

2. The cracked and heaved section of the patio presents a trip hazard. This condition should be corrected for improved safety. (See Photo 1)

- ! 1. The cracked and heaved section of the patio presents a trip hazard. This condition should be corrected for improved safety. (See Photo 1)
- ! 2. Damaged, open or missing wall and/or ceiling finishes of attached garages should be repaired and sealed where they abut the interior of a house. This reduces the potential of toxic automobile gases entering the house and serves as a fire break. Current standards require all walls/ceilings common to the finished living spaces be covered with 5/8" fire resistant sheetrock double taped at all seams. (See Illustration 3A) (See Photo 9)

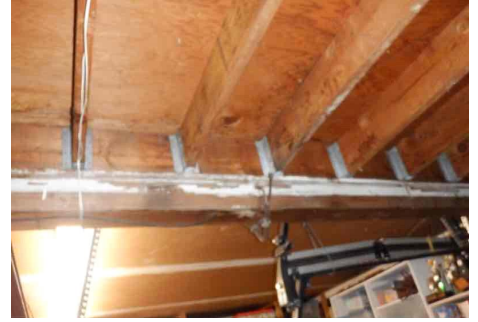
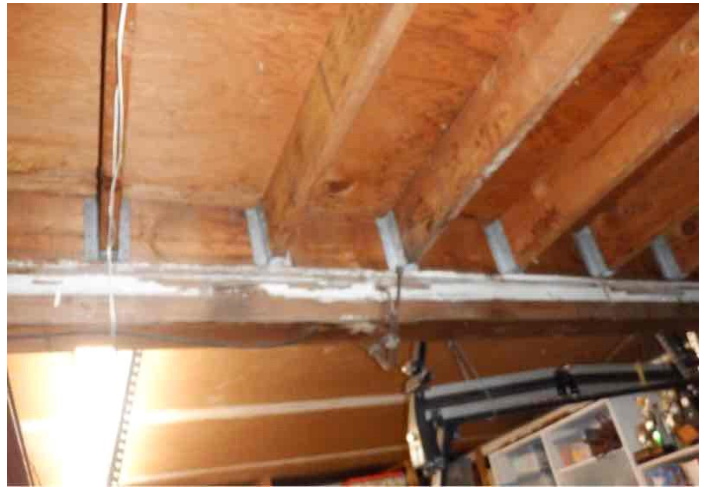
Photo 08

4. Water stains were noted on the ceiling of the garage. This is usually an indication of past plumbing or roof leaks. This area should be further evaluated by the appropriate trades. (See Photo 8)

- ! 3. Water stains were noted on the ceiling of the garage. This is usually an indication of past plumbing or roof leaks. This area should be further evaluated by the appropriate trades. (See Photo 8)

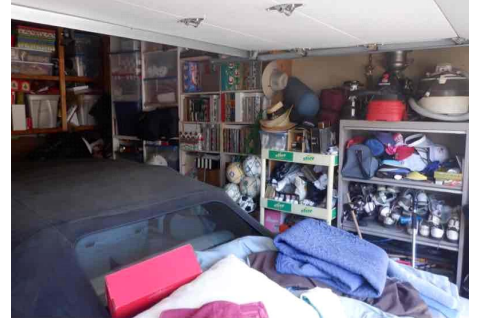
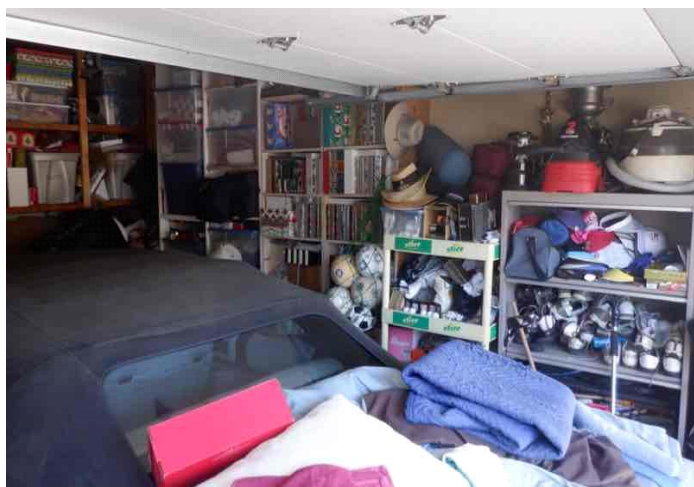
Photo 03

5. Personal storage was blocking access to the interior of the garage. Therefore, the area is considered inaccessible and was not fully inspected. With access and an opportunity for complete inspection, conditions in need of attention may be discovered. Ideally, the personal belongings should be removed so the area may be inspected. (See Photo 3) (See Photo 4)

Personal storage was blocking access to the interior of the garage. Therefore, the area is considered inaccessible and was not fully inspected. With access and an opportunity for complete inspection, conditions in need of attention may be discovered. Ideally, the personal belongings should be removed so the area may be inspected. (See Photo 3) (See Photo 4)

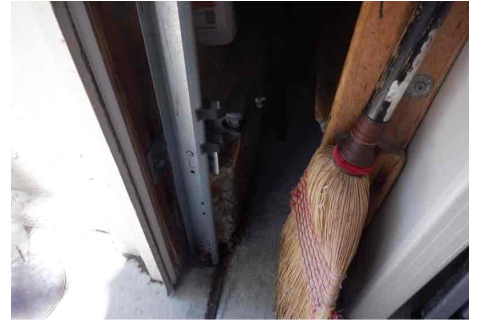
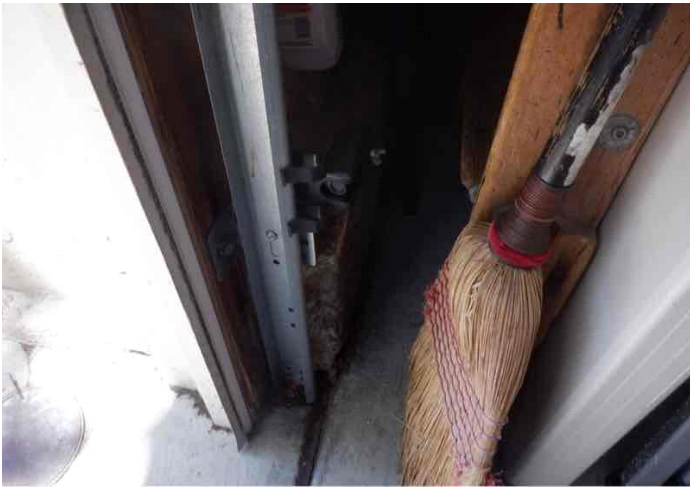
Photo 07

6. The garage door did reverse properly when the infrared detection system for the auto reverse was tested; however, we did note that the detection system for the auto reverse was installed too high or too low from the ground. We recommend proper mounting of the devices on the base of the garage jambs between 4" to 8" inches from the ground as per manufacturers recommendations. Information on the garage door openers is available from the consumer product safety commission at www.cpsc.gov. (See Illustration 3B) (See Photo 7)

- ! 4. The garage door did reverse properly when the infrared detection system for the auto reverse was tested; however, we did note that the detection system for the auto reverse was installed too high or too low from the ground. We recommend proper mounting of the devices on the base of the garage jambs between 4" to 8" inches from the ground as per manufacturers recommendations. Information on the garage door openers is available from the consumer product safety commission at www.cpsc.gov. (See Illustration 3B) (See Photo 7)

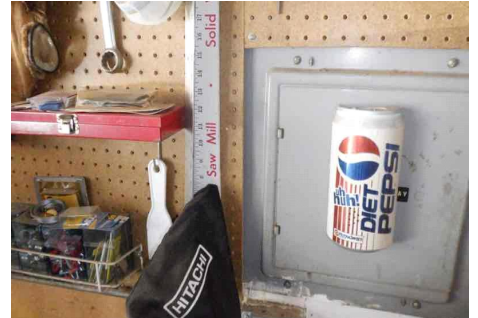
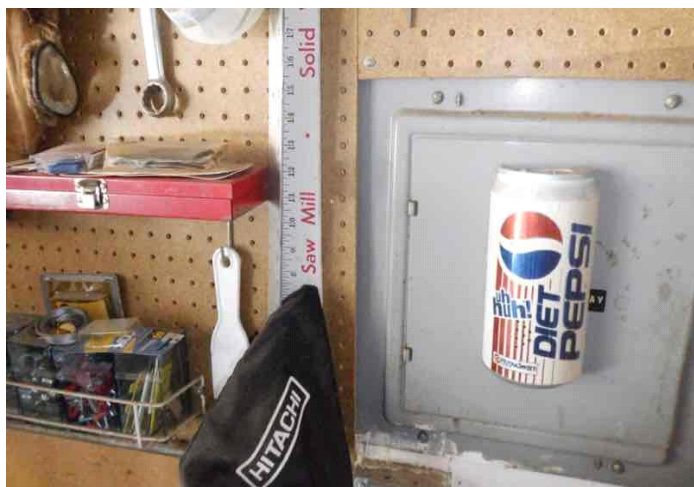
Photo 05

7. The branch/auxiliary electrical panel was obstructed and inaccessible at the time of our inspection. We recommend the circuitry and wiring in the panel be inspected by the appropriate trades when the obstructions/storage is removed. (See Photo 5)

- ! 1. The branch/auxiliary electrical panel was obstructed and inaccessible at the time of our inspection. We recommend the circuitry and wiring in the panel be inspected by the appropriate trades when the obstructions/storage is removed. (See Photo 5)

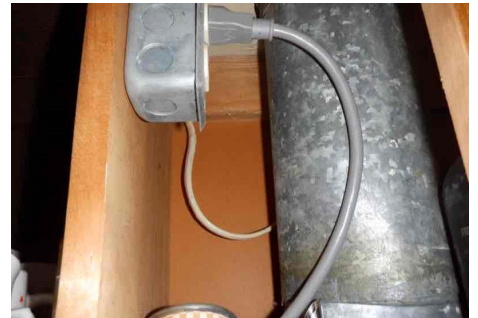
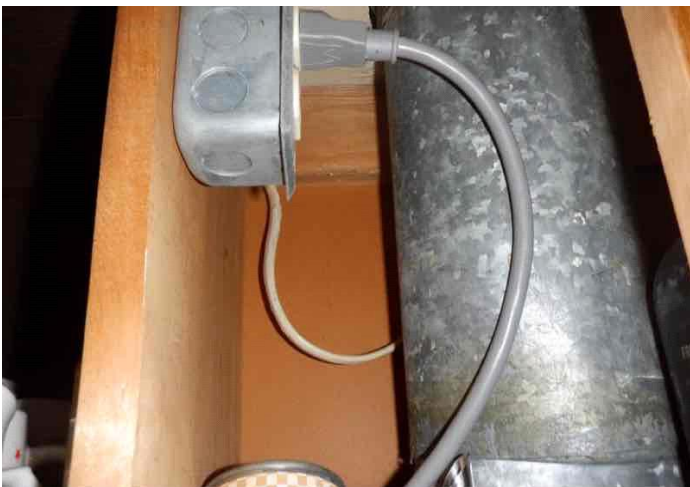
Photo 11

8. Exposed wiring inside the kitchen hood cabinet should be relocated, covered or protected by rigid conduit. (See Photo 11)

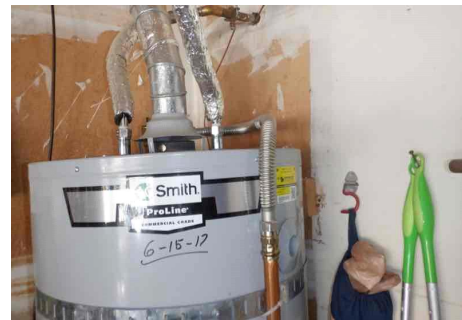
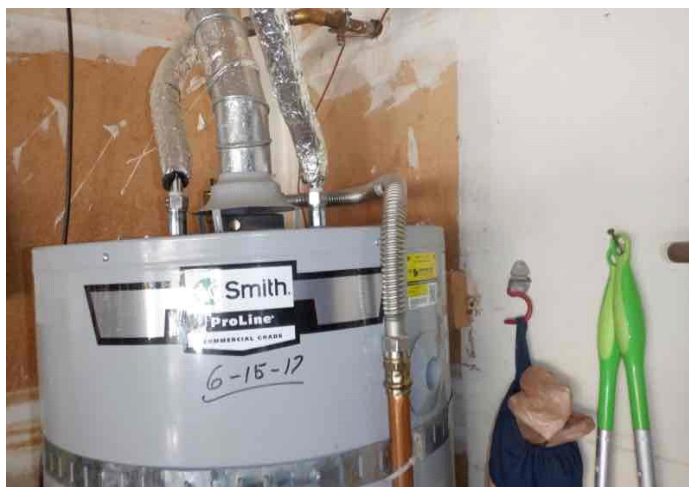
Photo 06

9. The temperature and pressure relief discharge pipe for the water heater is improper. We recommend the installation of a proper discharge pipe to an approved location. (See Photo 6)

- ! 1. The temperature and pressure relief discharge pipe for the water heater is improper. We recommend the installation of a proper discharge pipe to an approved location. (See Photo 6)

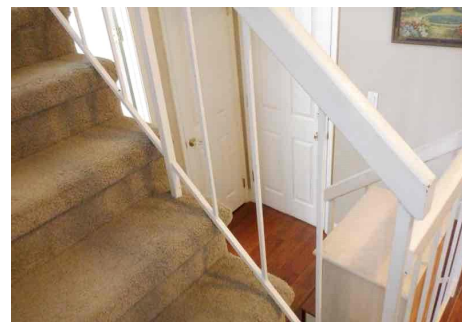
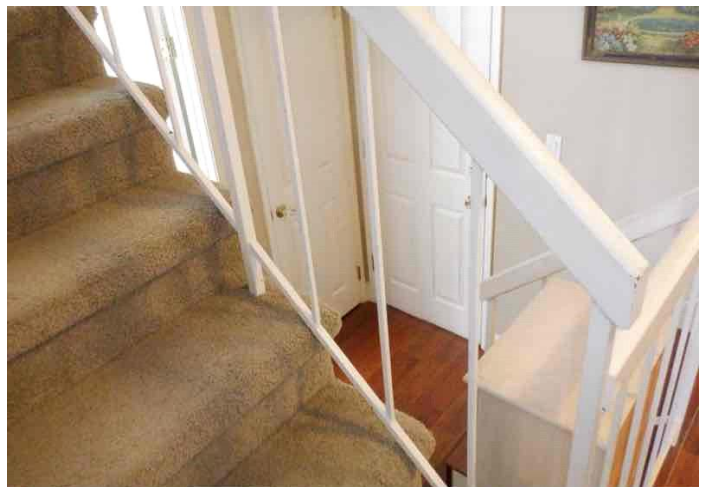
Photo 12

10. The openings in the interior railings are larger than 4". For improved safety it is recommended that the railing be altered for an opening of less than 4". (See Illustration 9K) (See Photo 12)

- ! 1. The openings in the interior railings are larger than 4". For improved safety it is recommended that the railing be altered for an opening of less than 4". (See Illustration 9K) (See Photo 12)

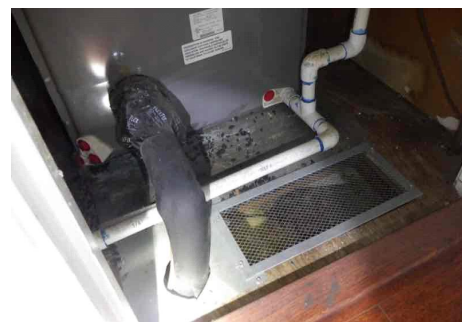
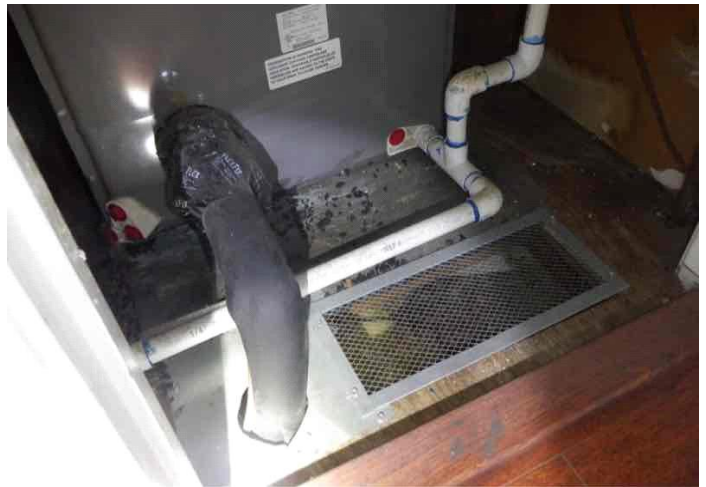
Photo 10

12. There is evidence of Vermin activity in the structure. It is likely that this infestation is also in inaccessible areas. The owner is advised to contact the appropriate trades for all remedial measures necessary. (See Photo 10)

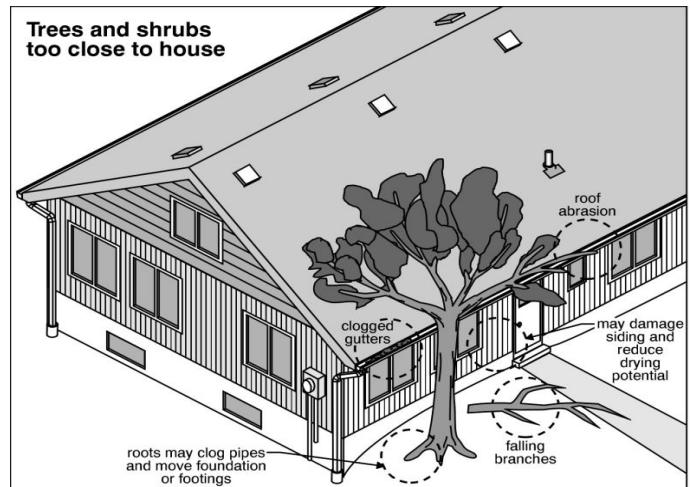
Illustration 3T

7. The tree proximity at the front of the building could disrupt drainage pipes, cause mechanical damage to the exterior of the house or influence the foundation over time. For additional information and recommendations we recommend appropriate trades be consulted. (See Illustration 3T)

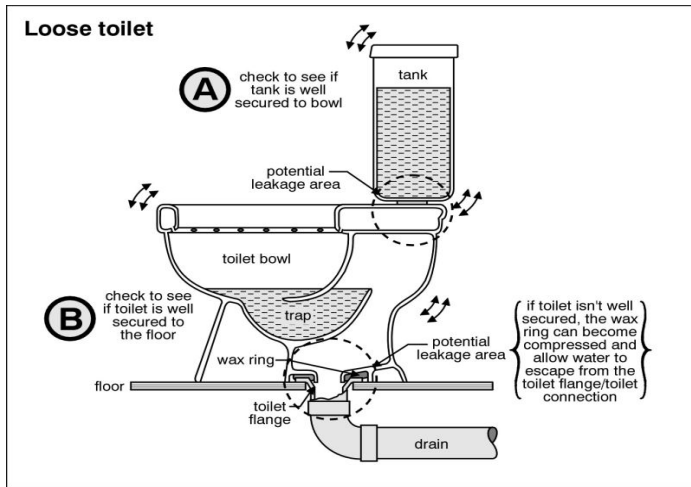
Illustration 8J

7. The toilet in the master bathroom is loose and should be properly re-secured, tightened and caulked. (See Illustration 8J)
