# WOOD DESTROYING PESTS AND ORGANISM INSPECTION REPORT

Building No. <b>4333</b>	Street <b>Camellia Court</b>	City <b>Pleasanton</b>	ZIP <b>94588</b>	Date of Inspection <b>5/11/2021</b>	Number of Pages <b>Page 1 of 7</b>
-----------------------------	---------------------------------	---------------------------	---------------------	--	---------------------------------------

General Description: <b>This is a two story single family dwelling with stucco exterior, limited to the main structure, excluding the attached deck.</b>	Inspection Tag Posted: <b>Garage</b>
	Other Tags Posted:

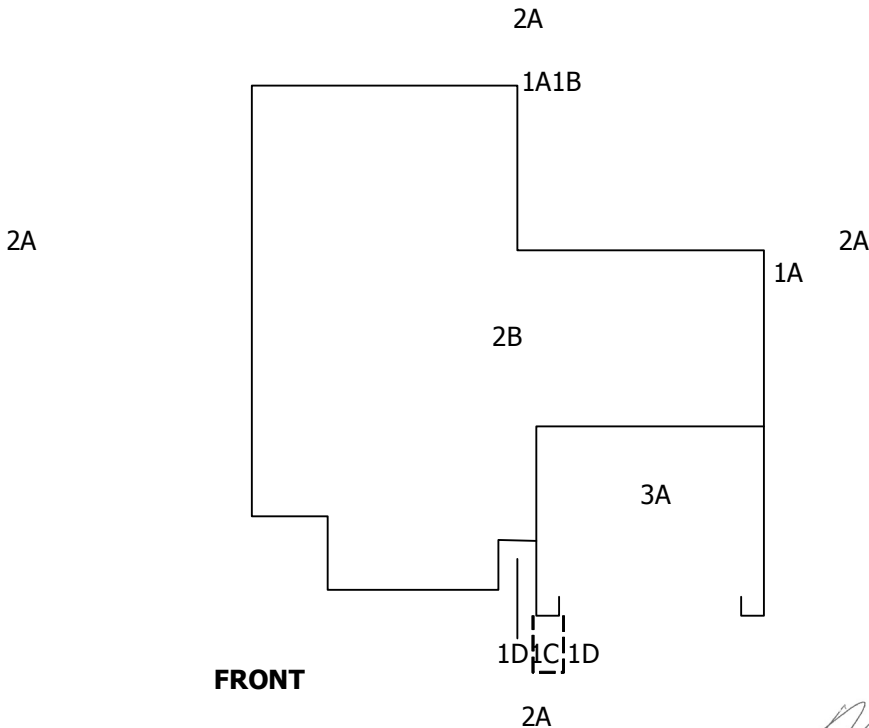
**Key to Items on diagram: [1] Section 1 Items [2] Section 2 Items [3] Unknown Further Inspection Items**

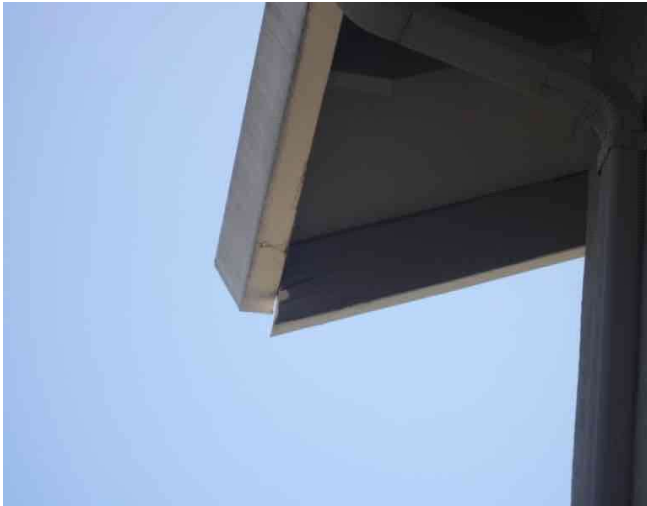
Photo 01

**1A. FINDING:** The barge rafter(s) as indicated on the diagram are damaged by fungus. The contributing moisture source appears to be exposure to the weather. (See Photo 1)

**RECOMMENDATION:** Remove and replace a section of the damaged barge rafter(s) to correct this condition. This bid includes repair of the roof covering if disturbed by our repairs. If existing gutters need to be removed to perform the repairs then our bid also includes reinstallation of original gutters. If it becomes necessary or desirable to install new gutters this will be done only if authorized and at an additional cost. The guarantees on the roof covering are limited to the areas where the work was performed.

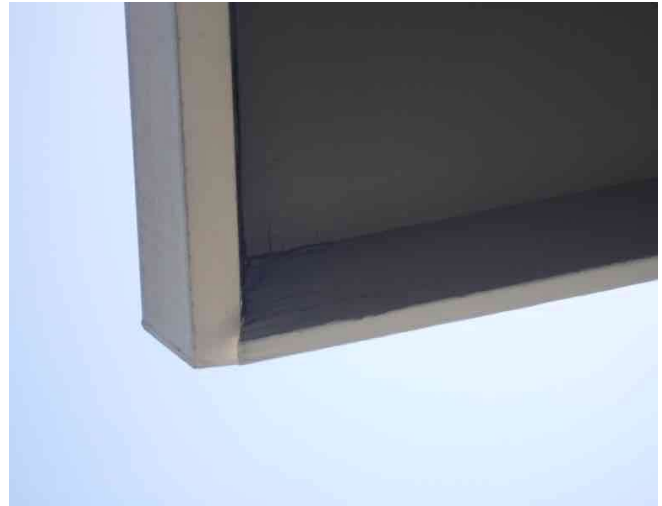
Photo 02

**1B. FINDING:** The roof sheathing has been damaged by fungus where indicated on the diagram. The contributing moisture source appears to have been caused by a failure of the roof covering. (See Photo 2)

**RECOMMENDATION:** Remove and replace the damaged sheathing to correct this condition. This bid includes repair of the roof covering if disturbed by our repairs. If existing gutters need to be removed to perform the repairs then our bid also includes reinstallation of original gutters. If it becomes necessary or desirable to install new gutters this will be done only if authorized and at an additional expense. The guarantees on the roof covering are limited to the areas where the repairs were performed.

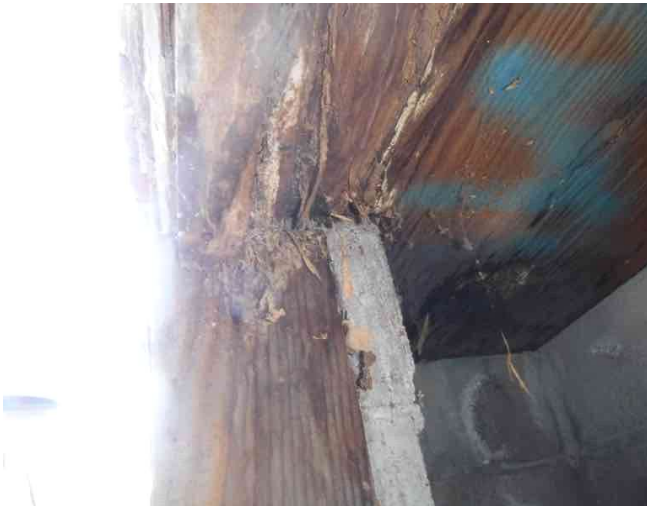
Photo 03

**1C. FINDING:** The front abutment has been damaged by fungus and subterranean termites at the area indicated on the diagram. (See Photo 3) (See Photo 4) (See Photo 5)

**1D. FINDING:** Subterranean termites have entered the structure from the earth fill under the abutment. (See Photo 3) (See Photo 4)

**RECOMMENDATION:** Remove a sufficient amount of exterior stucco to affect repairs. Remove and dispose of the damaged abutment framing and opening. Install new materials where removed. Install new paper and wire. Re-stucco the exterior where removed. The new stucco texture will vary from the existing. HomeGuard will apply one coat of primer paint to the repaired area. If any damage is found to extend into any enclosed areas, a supplemental report and bid will be issued.

**RECOMMENDATION:** Drill holes through the area indicated on the diagram and inject Termidor HE (Fipronil:5-amino-1-(2,6-dichloro-4-(trifluoromethyl) phenyl)-4-((1,R,S)-trifluoromethyl)sulfinyl)-1-H-pyrazole-3-carbonitrile) into the earth below and break down and brush away all subterranean termite migratory tubes. We will be as careful as possible with our repair; however, we assume no responsibility for any damage to the surface covering the floor in the area to be treated. If any concealed pipes, conduit or electrical wiring or other facilities are drilled into during the course of performing this item it will be the owners responsibility and cost to repair these items. **NOTE:** In order to perform this treatment the property must be vacated during the treatment and three hours after the treatment is performed.

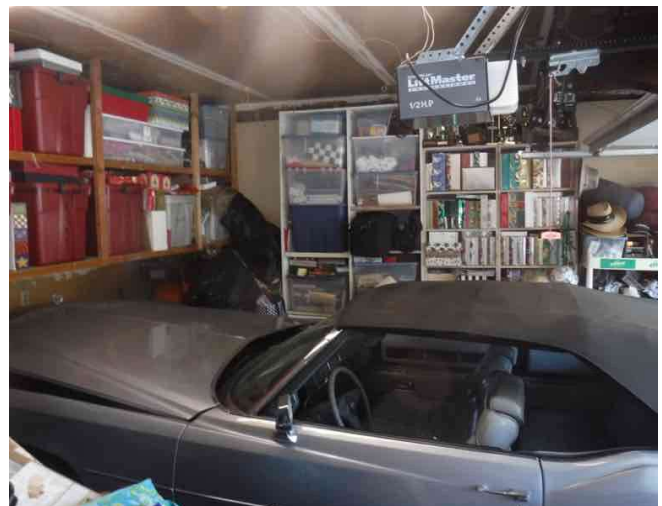
Photo 06

**3A. FINDING:** We were unable to inspect the interior of the garage due to stored personal property. (See Photo 6)

**RECOMMENDATION:** The owner should move the storage away from the garage walls to allow for further inspection. All findings, recommendations, and bids will be issued in a supplemental report.
