## Roof Inspection Report

**4333 Camellia Court, Pleasanton**

**Matthew Robinson**  
May 11, 2021  
Reg No. 118122 SP

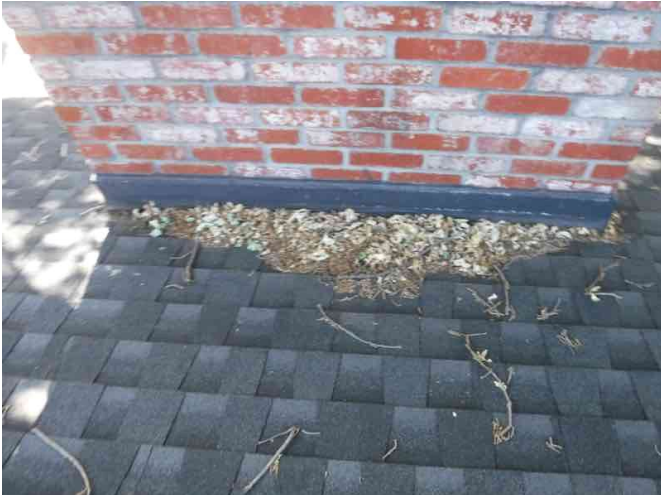
Photo 01

1. There is debris on the roof that impedes water travel. (See Photo 1) (See Photo 5)

Clear roof of all debris; this a one time service. If additional damage is revealed after debris is removed, a supplemental report will be issued with additional findings and recommendations.

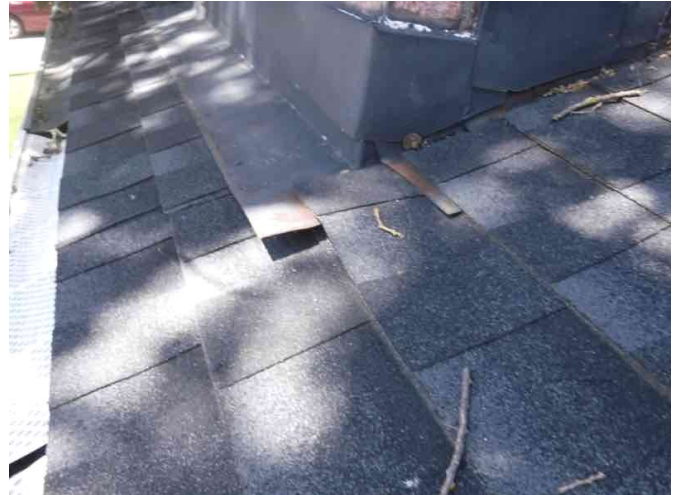
Photo 02

2. The chimney flashing is not properly secured and is beginning to pull up away from the roof surface, this condition may allow wind driven rain to penetrate the flashing and into the structure. (See Photo 2)

Secure the chimney flashing as needed to ensure a water-tight condition. If the area is over a painted surface, we will paint to match as closely as possible for cosmetic reasons. Weather permitting.

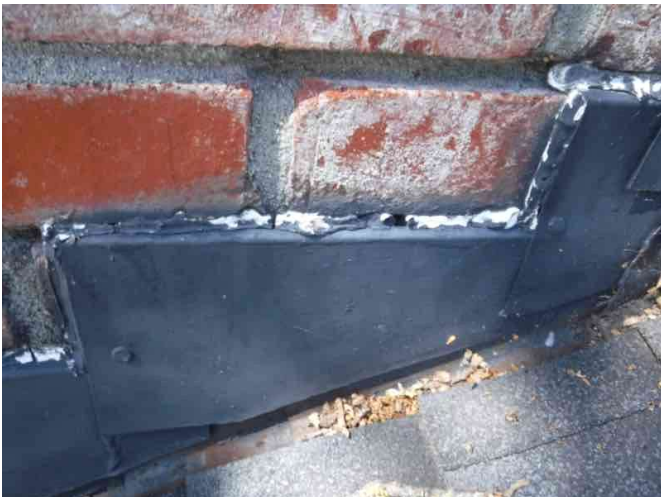
Photo 03

3. The chimney counter flashing requires sealing. (See Photo 3)

Seal the chimney counter flashing with caulking/mastic as required to ensure a watertight condition.

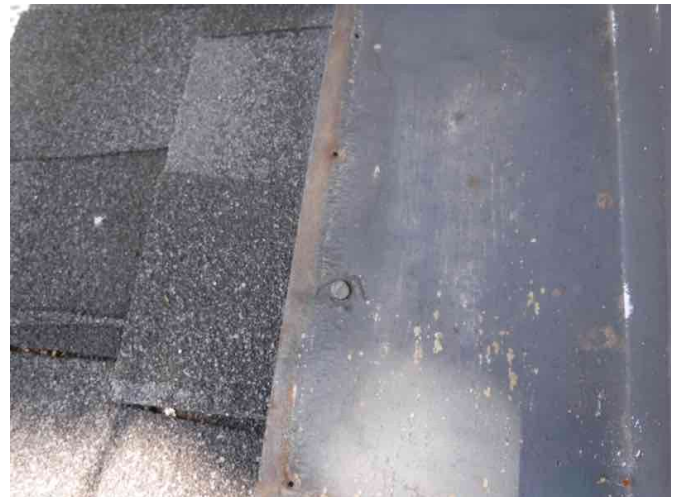
Photo 04

4. There are exposed fasteners in the field that may leak if not sealed. (See Photo 4)

Seal all exposed fasteners in the field using approved caulking or mastic.

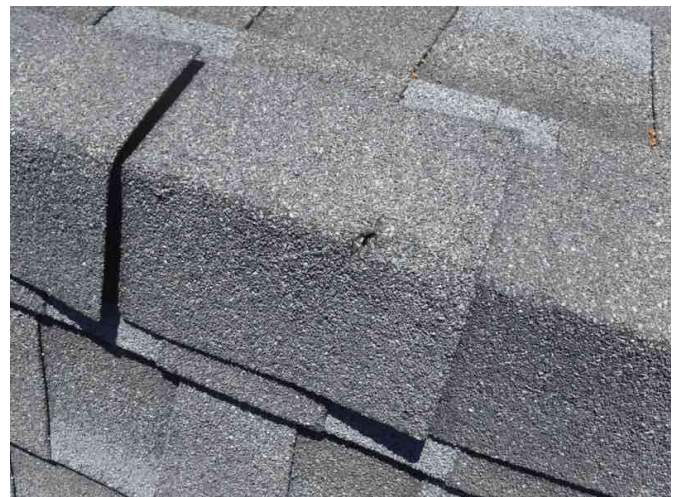
Photo 06

5. There are a few damaged ridge caps. (See Photo 6)

Replace and/or repair all damaged ridge caps where needed to ensure a watertight condition. We will use closest matching material available.

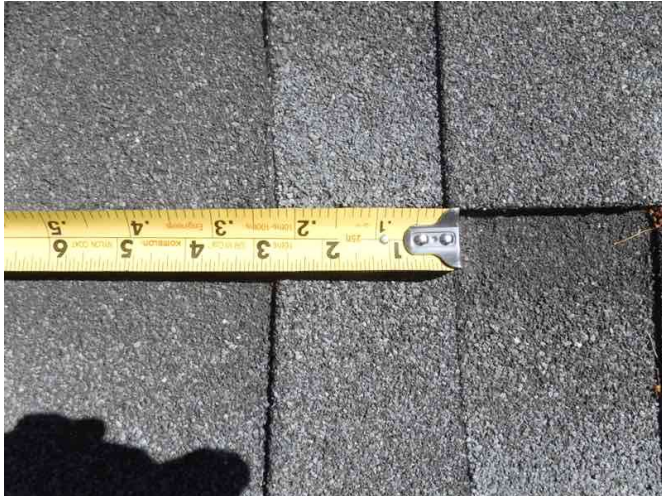
Photo 07

6. The shingle strip offset should be a minimum of 4-1/2" from the edge of the underlying shingle courses; we noted several areas where this minimum requirement was not met: under extreme weather conditions water may travel underneath the shingles at the offset joint causing subsequent leakage. (See Photo 7) (See Photo 8) (See Photo 9)

Correctly remove and replace the shingles with a proper offset. We will use closest matching material available.

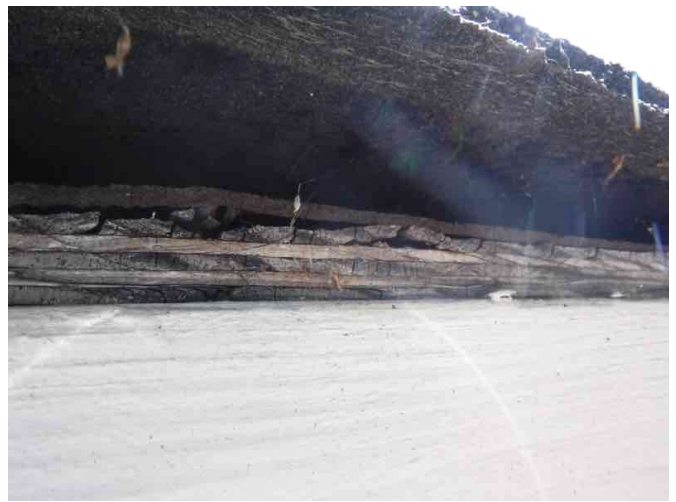
Photo 10

7. We noted exposed sheathing at the drip edges. To prevent premature wear and tear at these areas we recommend the installation of drip edge flashing (nosing). (See Photo 10)

Install nosing where sheathing is exposed at the drip edges. Bid does not include paint.
